Club Meeting Venue

The new Allcott Sports Club, prior to the February meeting.

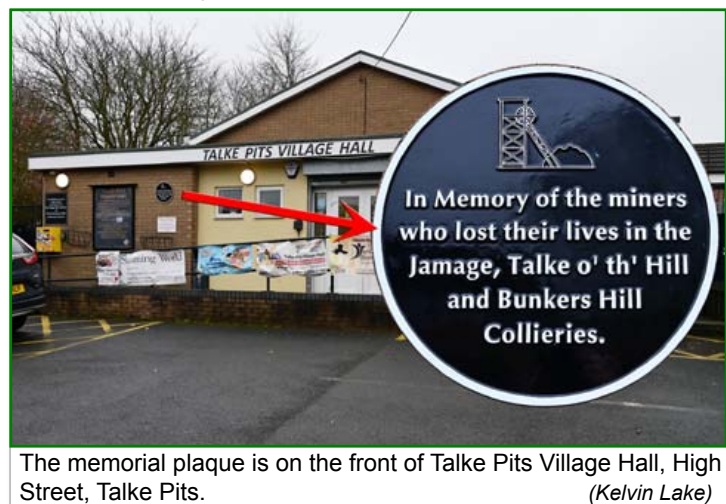
The memorial plaque is on the front of Talke Pits Village Hall, High Street, Talke Pits. (Kelvin Lake)

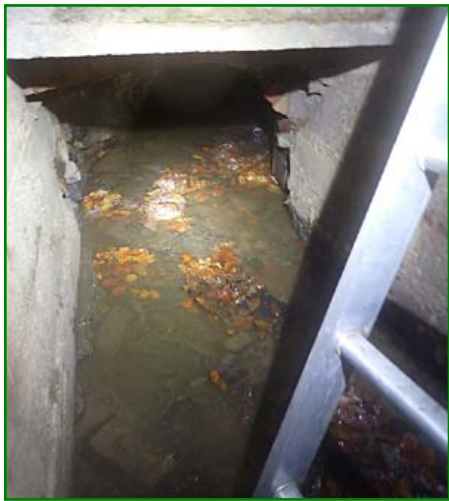
5. View below the manhole.
(Steve Holding)

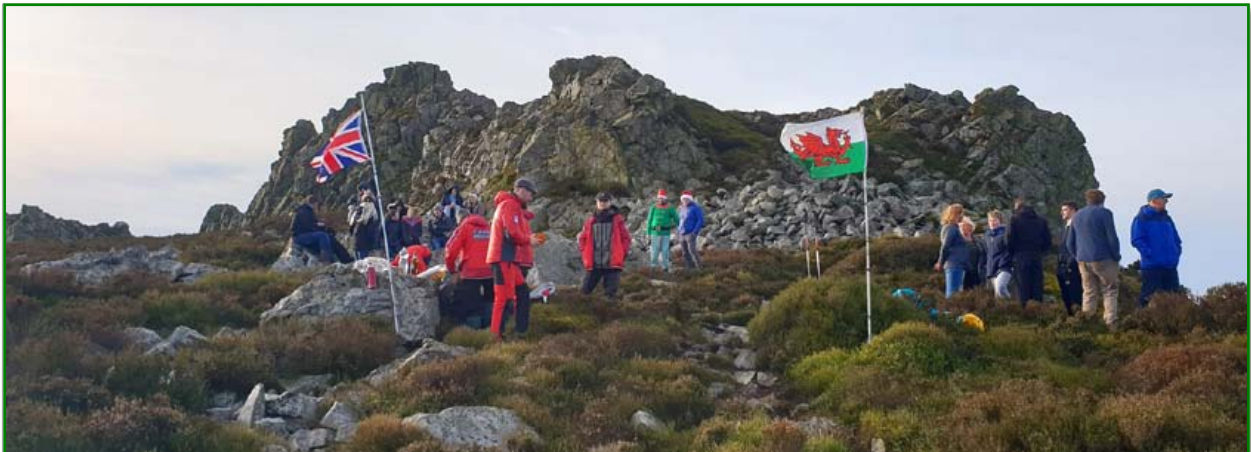
The race half-way point set-up, with onlookers waiting for the runners.

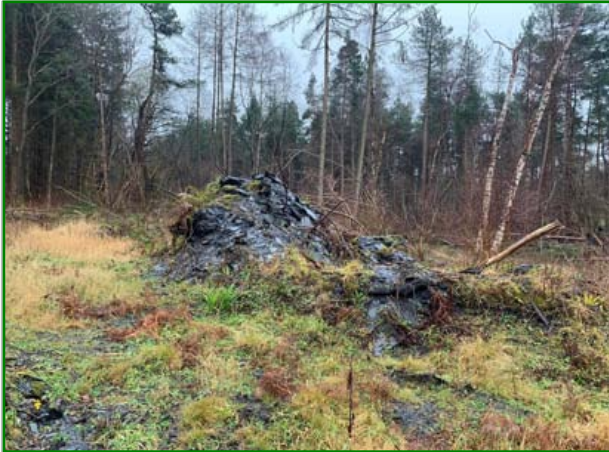
Remains of the haulage base at the head of the incline into Cambrian Slate quarry. *(Gareth Rushton)*

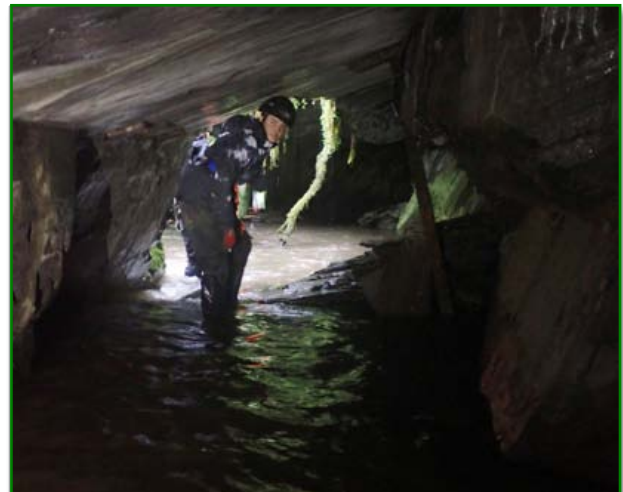
Emily in the main drainage level just before it enters one of the open quarry pits. *(Graham Smith)*

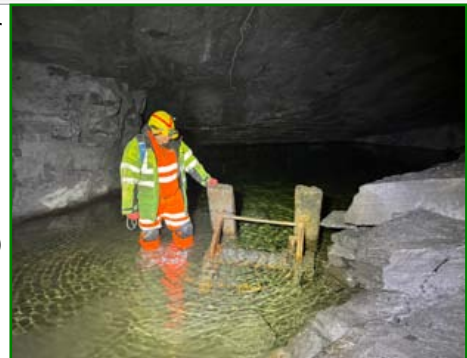
Returning up the concrete pipe was like leg day at the gym with the flow of water gushing against you, one piece of memorable advice on the day happened to be 'spread your legs' to which there were a number of smirks and chuckles.

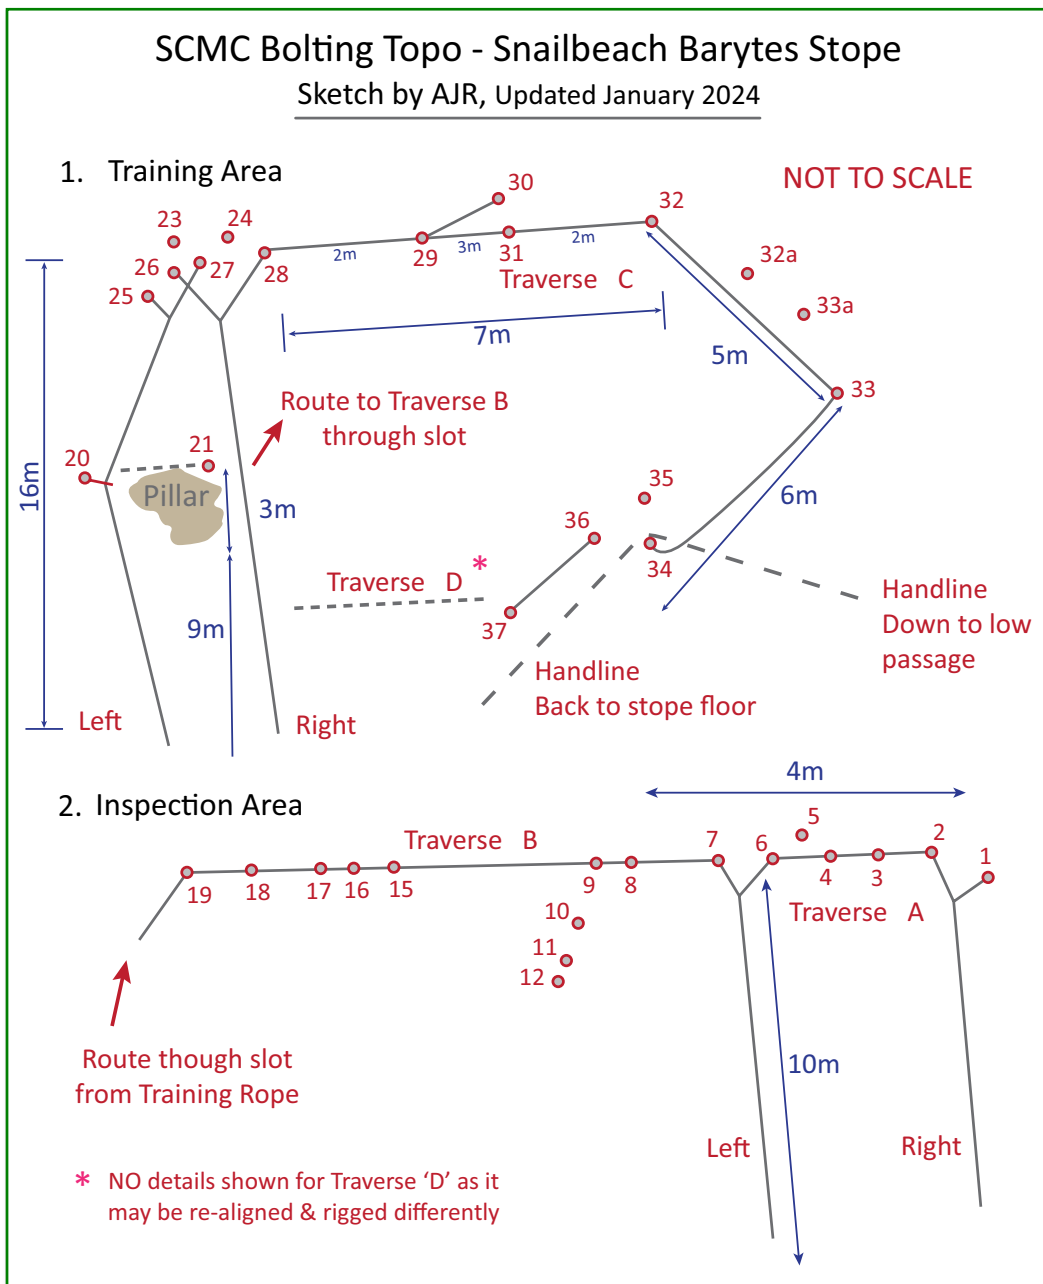
Friday 5th January - Burgam bat survey. Mike Worsfold, John Morgan, Vicky Robinson, Alan Robinson, plus members of the Bat Group.

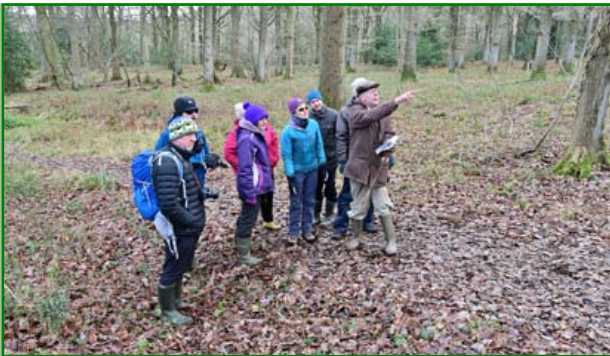
David Poyner explaining the remains of "bell pits" in Seckley woods. (Kelvin Lake)

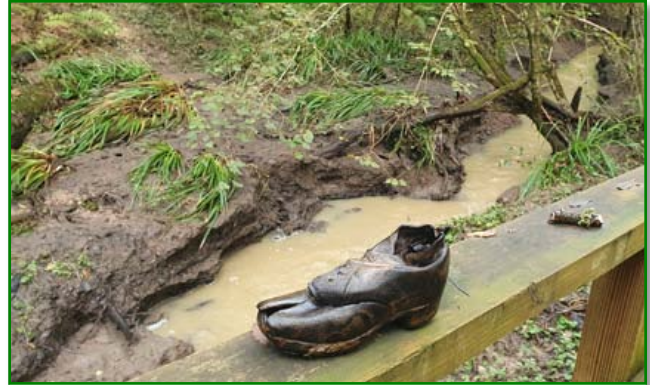
The boot on the bridge parapet near where it was found.
(James Hobson)

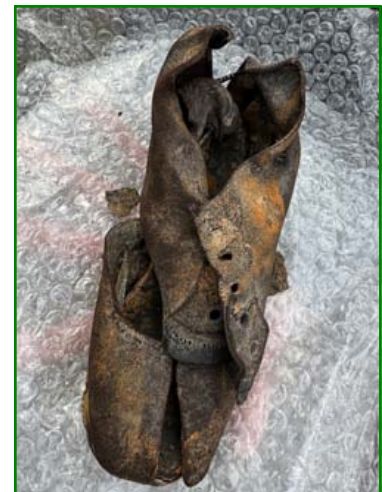
Above and below: Views of the Mamble boot.
(Kelvin Lake)

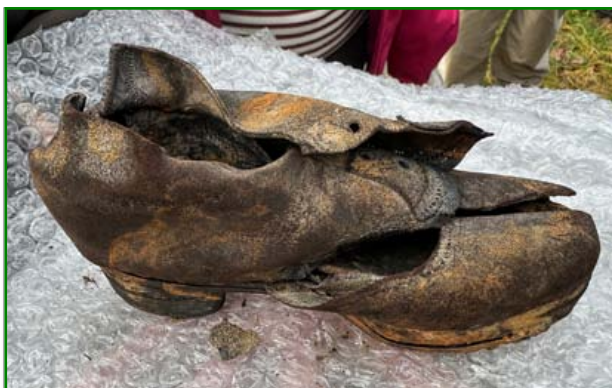
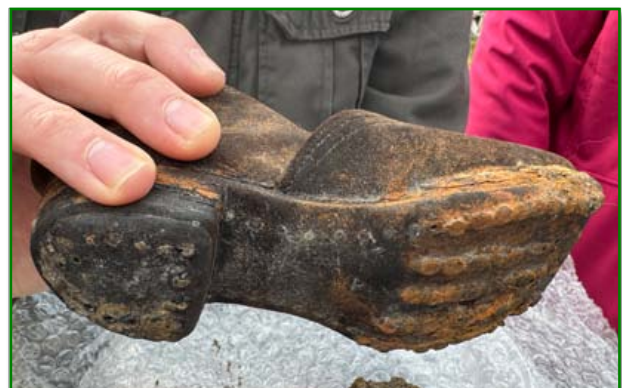
Cockshutford Quarry and associated workings on the Brown Clee

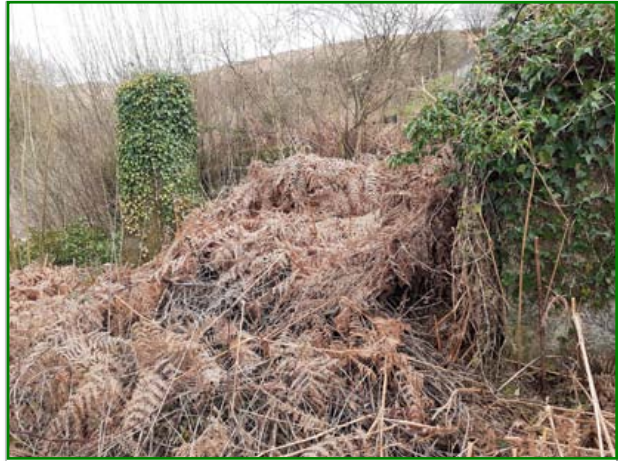
Figure 8: Central section of the crusher foundations, looking east from the engine base and showing the pylons, with the retaining wall in the background.
(David Poyner)

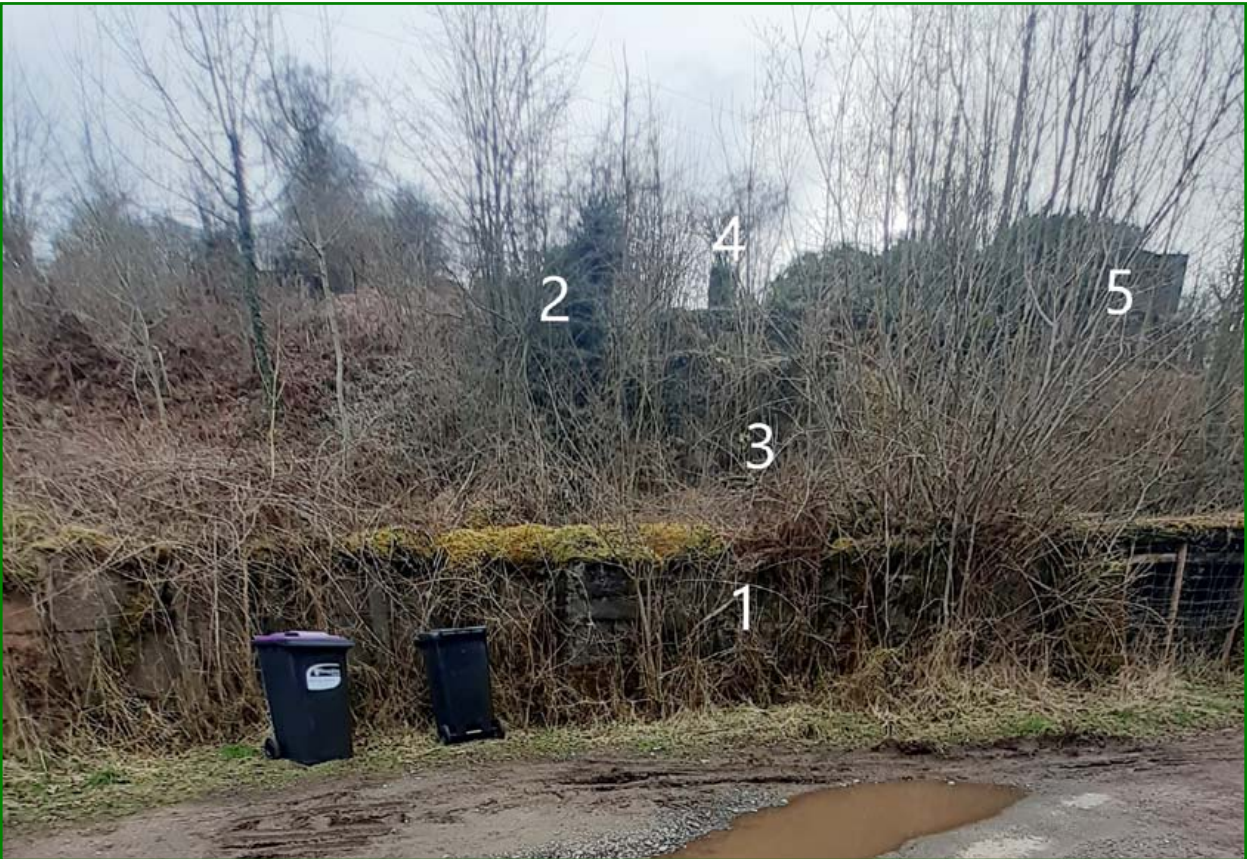
Figure 9: Loading platform (1), looking south with crusher remains in the background; retaining wall (2), granulator (3) pylons (4) and tank (5).
(David Poyner)

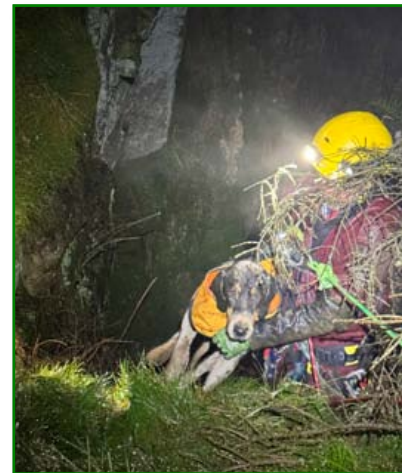
Graham Smith bringing the dog out of the stope. (Kelvin Lake)

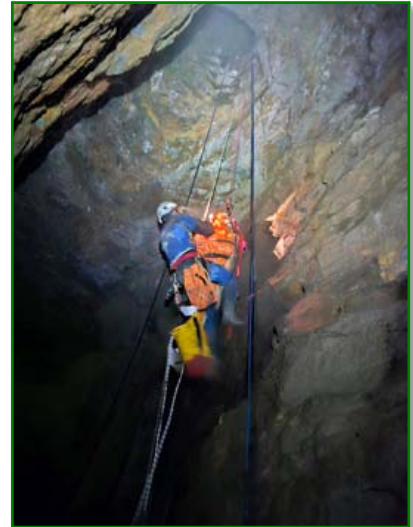
The stretcher and 'jockey' heading to the surface. (Devon CRO)

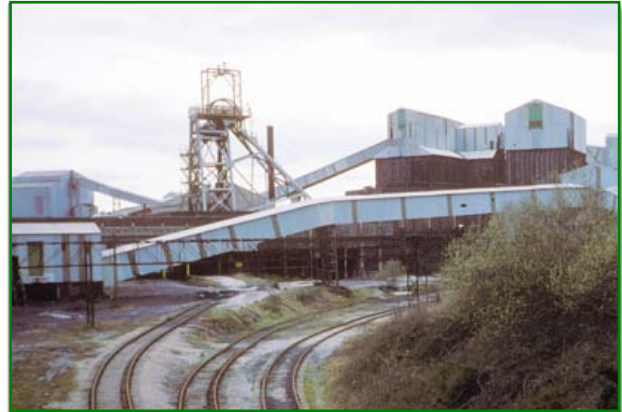
The railway sidings behind the screens. (Peter Eggleston - I.A.Recordings)

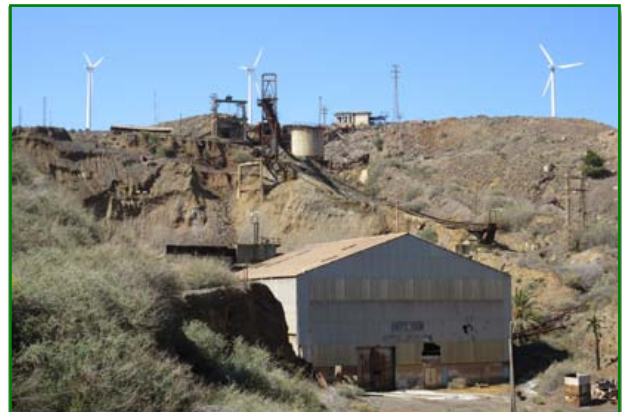
The lower section of the Semi-autogenous mill. (Andy Wood)

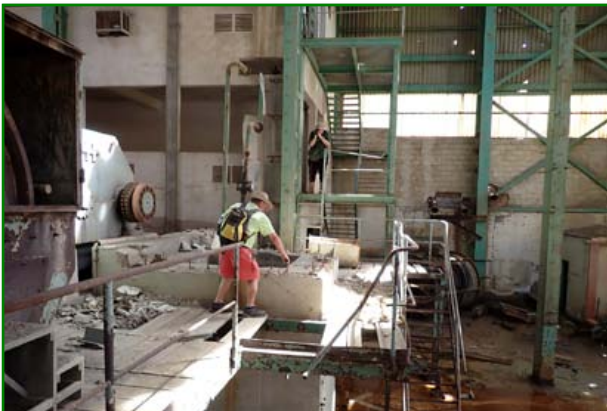
Andy and Peter inside the lower (grinding plant) section of the Semi-autogenous mill. (Steve Holding)

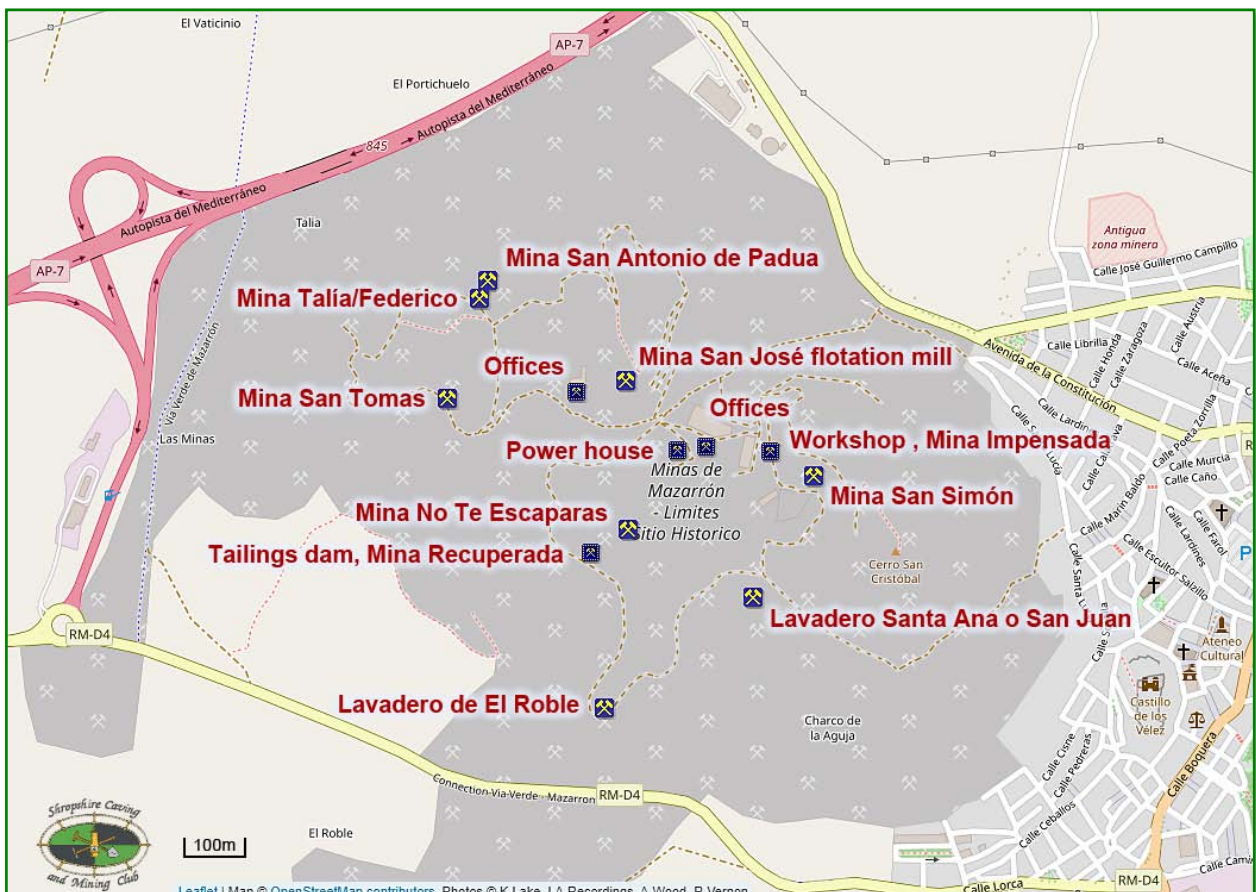
The main features of the historic mining area to the west of the town of Mazarrón.

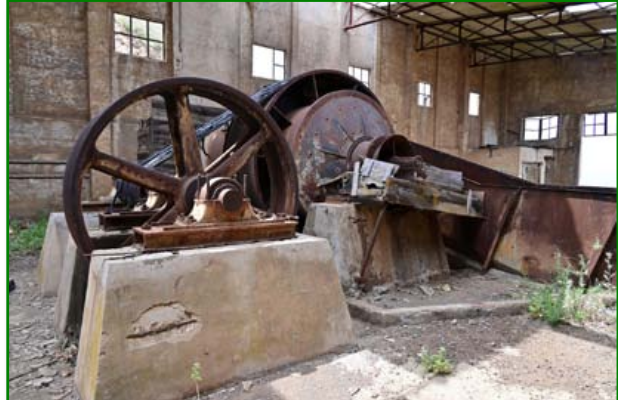
The ball mill with a multi-belt drive on the upper level of Lavadero San Isidoro. (Kelvin Lake)
